Demolition | Dismantling | Relocation

# VIEW ON DDM

# CONTENTS

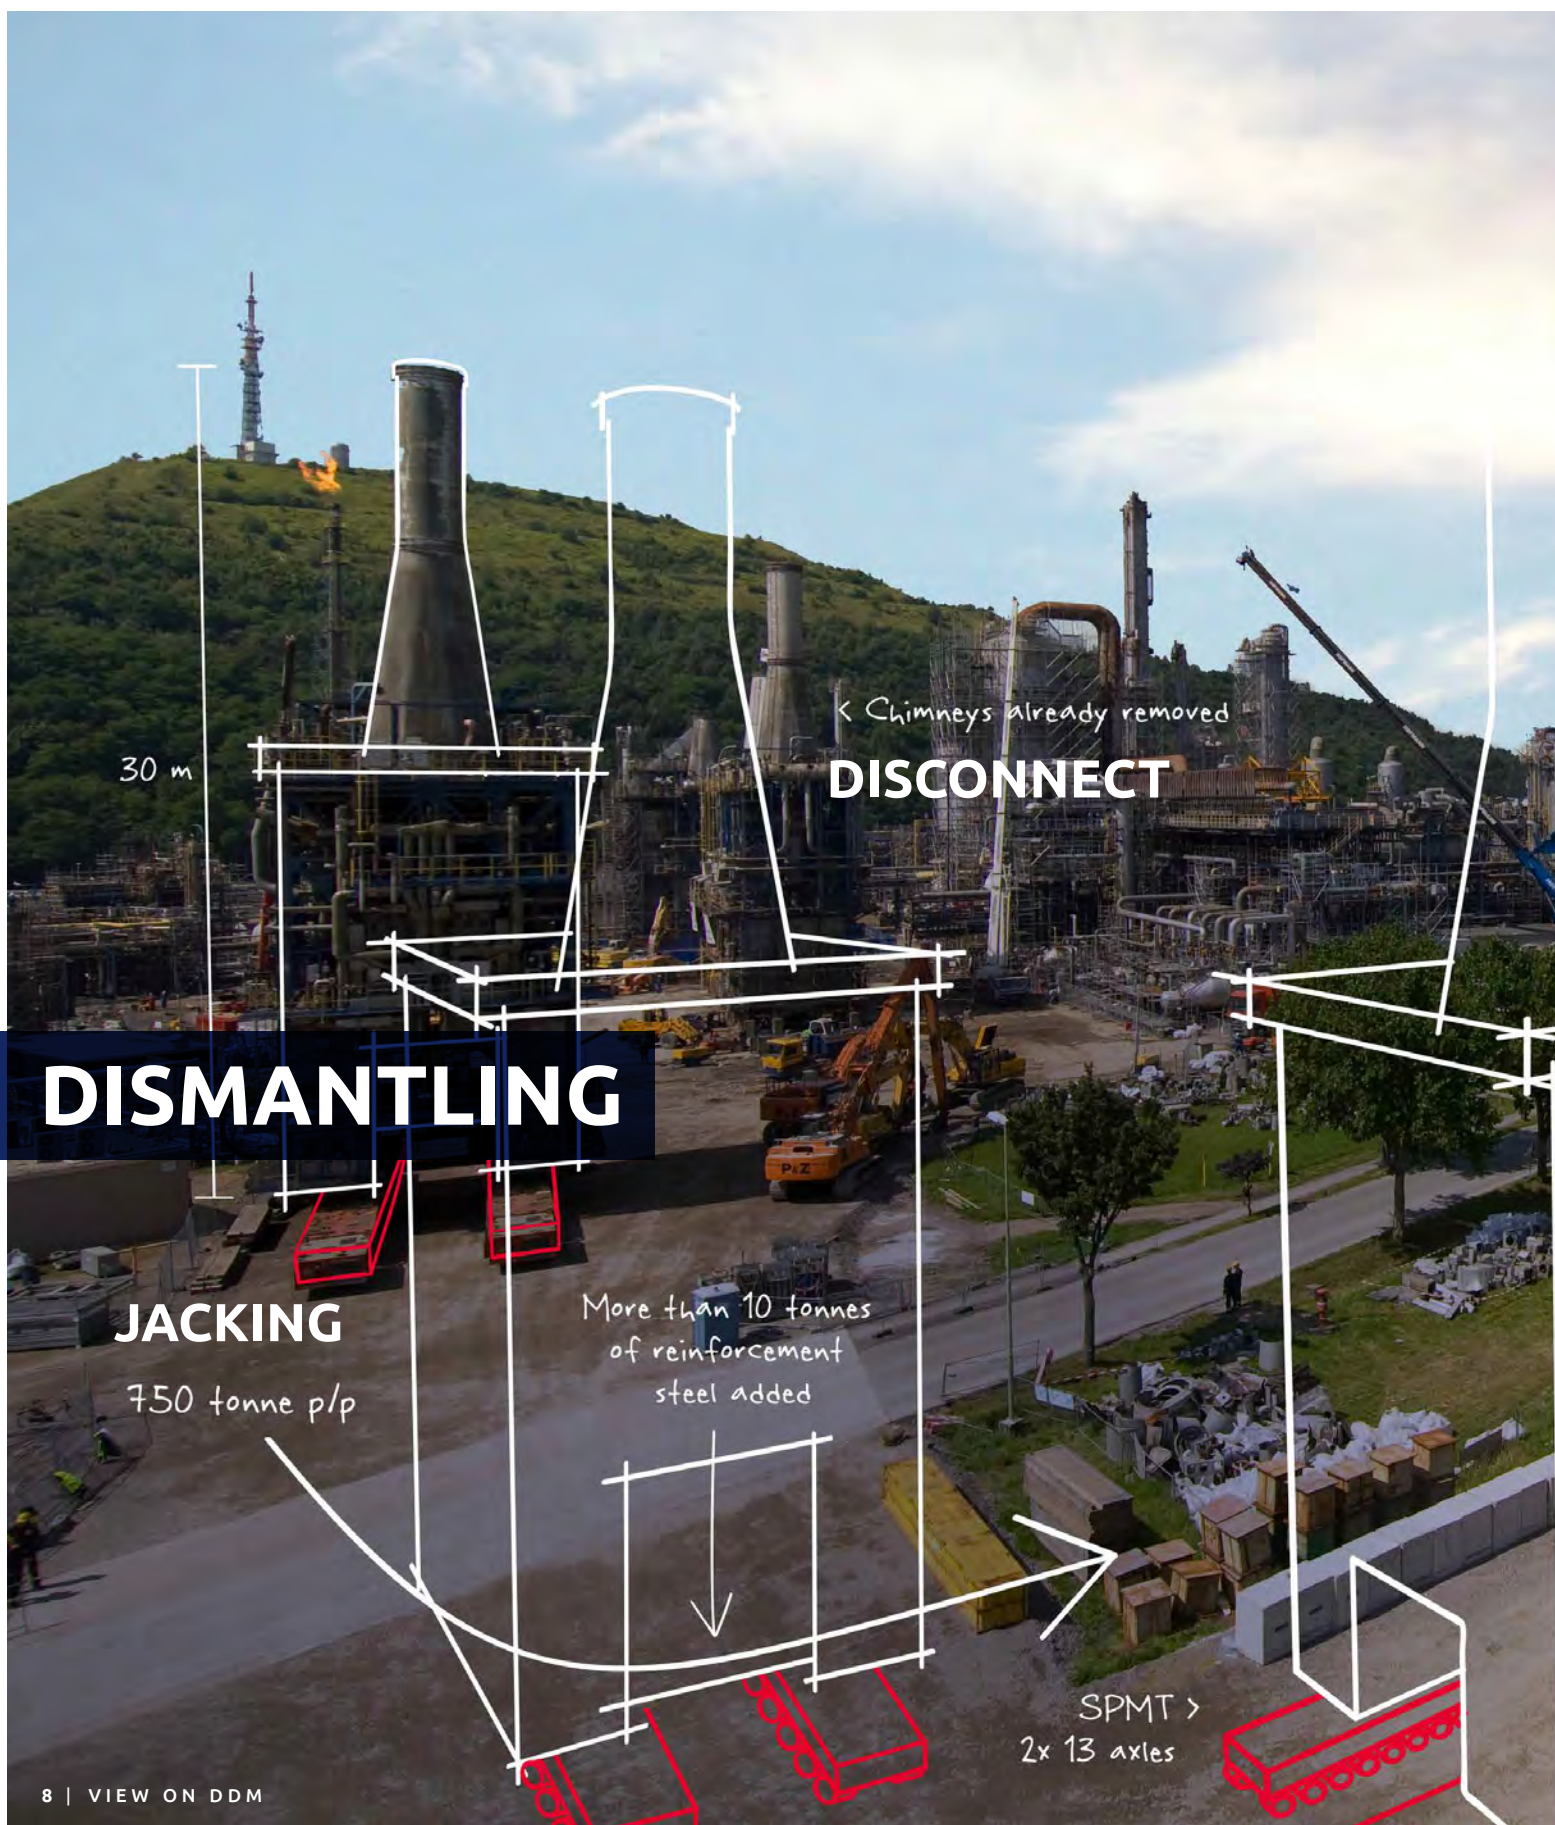
30 m

< Chimneys already removed

**JACKING**

750 tonne p/p

More than 10 tonnes  
of reinforcement  
steel added

SPMT >  
2x 13 axes

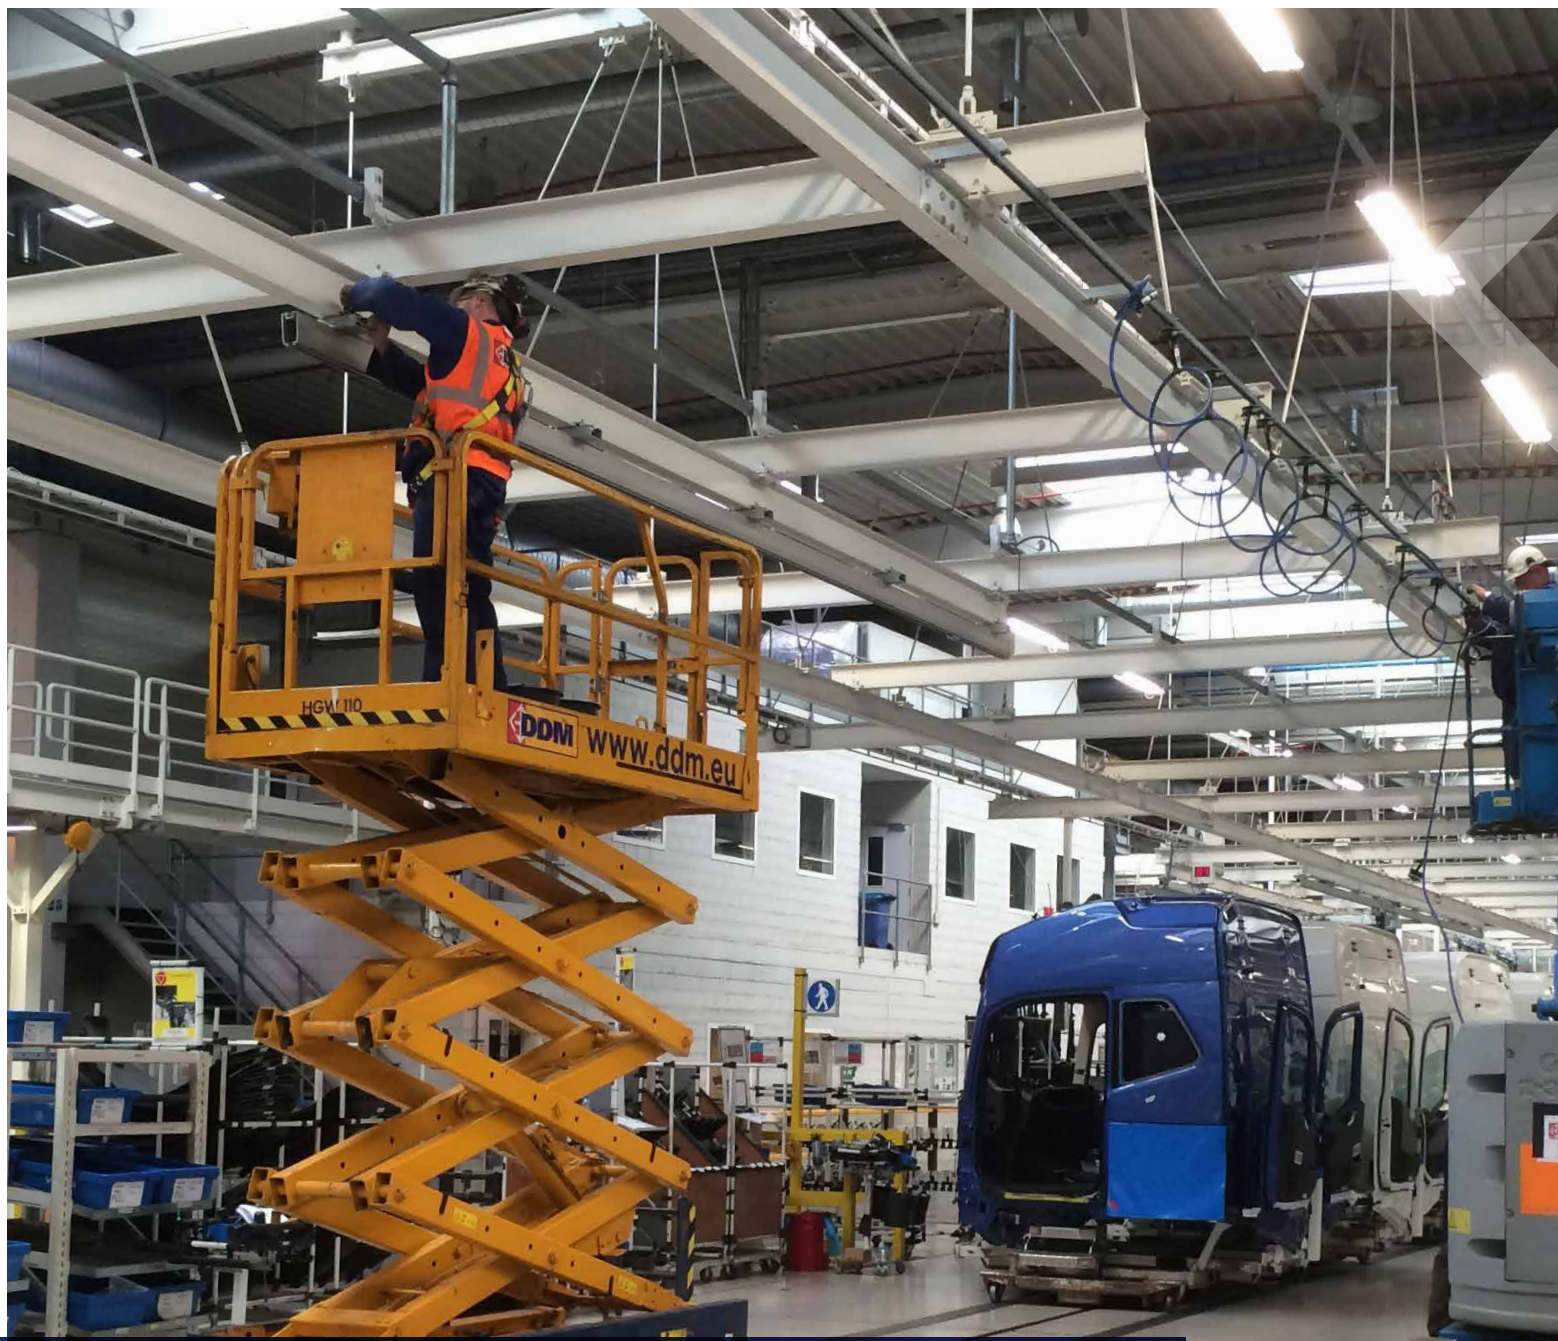
< Temporary  
foundations

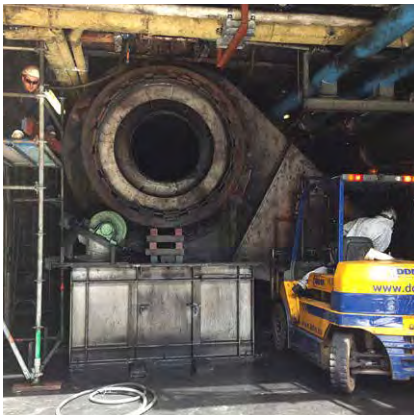
A custom-made frame held the dryers together.

To remove the dryers as a whole, the rotating inner mantle had to be fixed to the outer casing. A custom-made frame held the dryers together. After the frame was assembled, the drive train and motors of the dryers were removed.

The frame with the dryers was jacked up several millimetres so that the supports could be removed from under

the dryers. The dryers were then lowered again, put on the rails and towed outside. Once outside they were jacked up again to a height of about 1.5 metres. A self-propelled modular transporter (SPMT) was placed under the dryers. It then manoeuvred the machines out from the very tight space between the buildings.

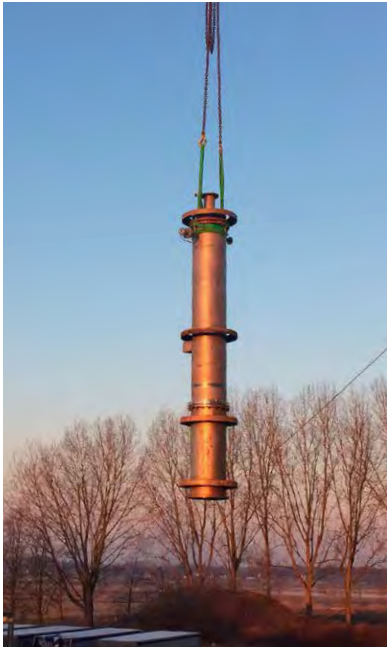
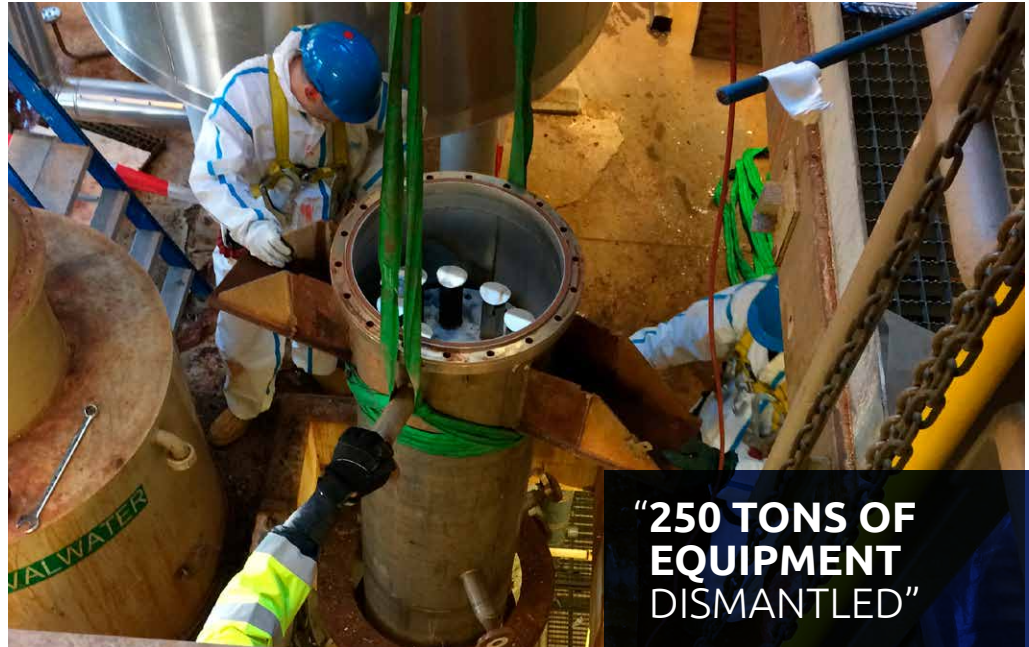
# Dismantling a complete factory and transporting it to Germany...

## DDM was responsible for dismantling an additives plant in Deventer.

This factory used a chemical agent that increased the lifespan of car tyres. To safely dismae the production line, the installation had to be thoroughly cleaned first. The piping was then removed to make room for dismantling the reactor vessels and heat exchangers. Due to the restricted space DDM used hoists

and sets of rollers to move the equipment from its place. After that the components were hoisted out of the building using a hydraulic crane. Final cleaning of the equipment was done in a spraying area set up specially for this purpose. A final inspection was then performed by the German TÜV.

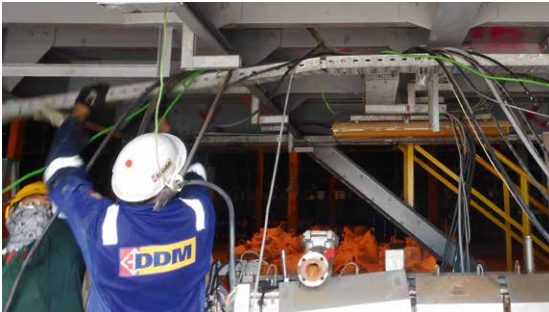
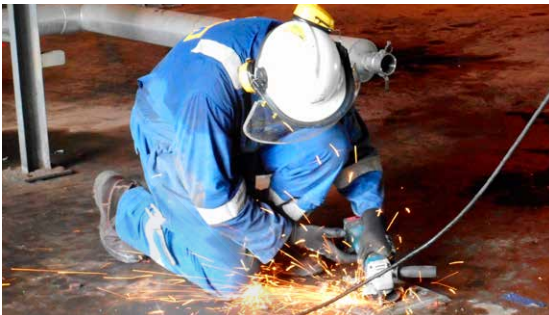
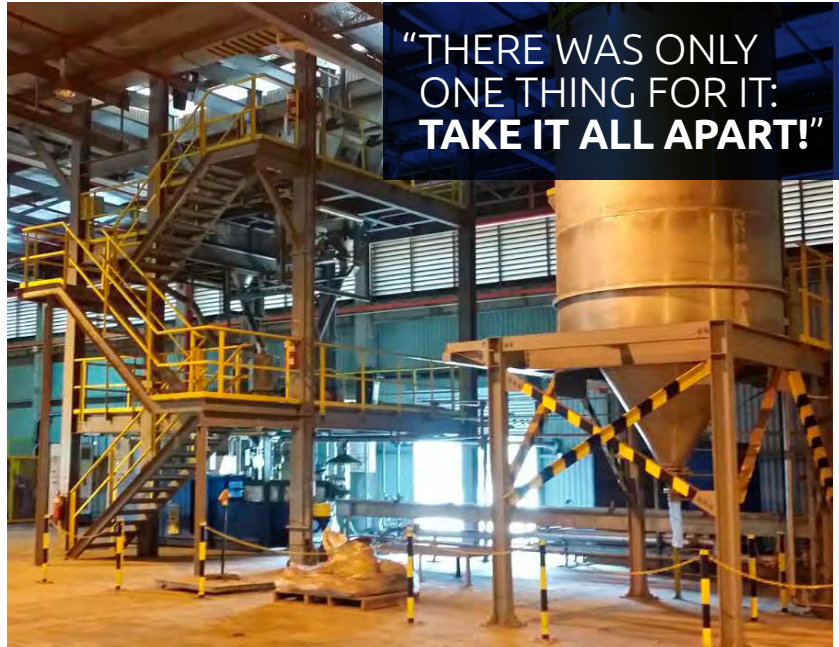
# How do you fit a compounding unit in **sea containers**?

**Scope:** 2 silos, extruder, transformer, electrical installation and part of the steel structure

In Kuantan (Malaysia), DDM efficiently dismantled a compounding unit, placed it in sea containers and shipped it to Egypt. An unusual job!

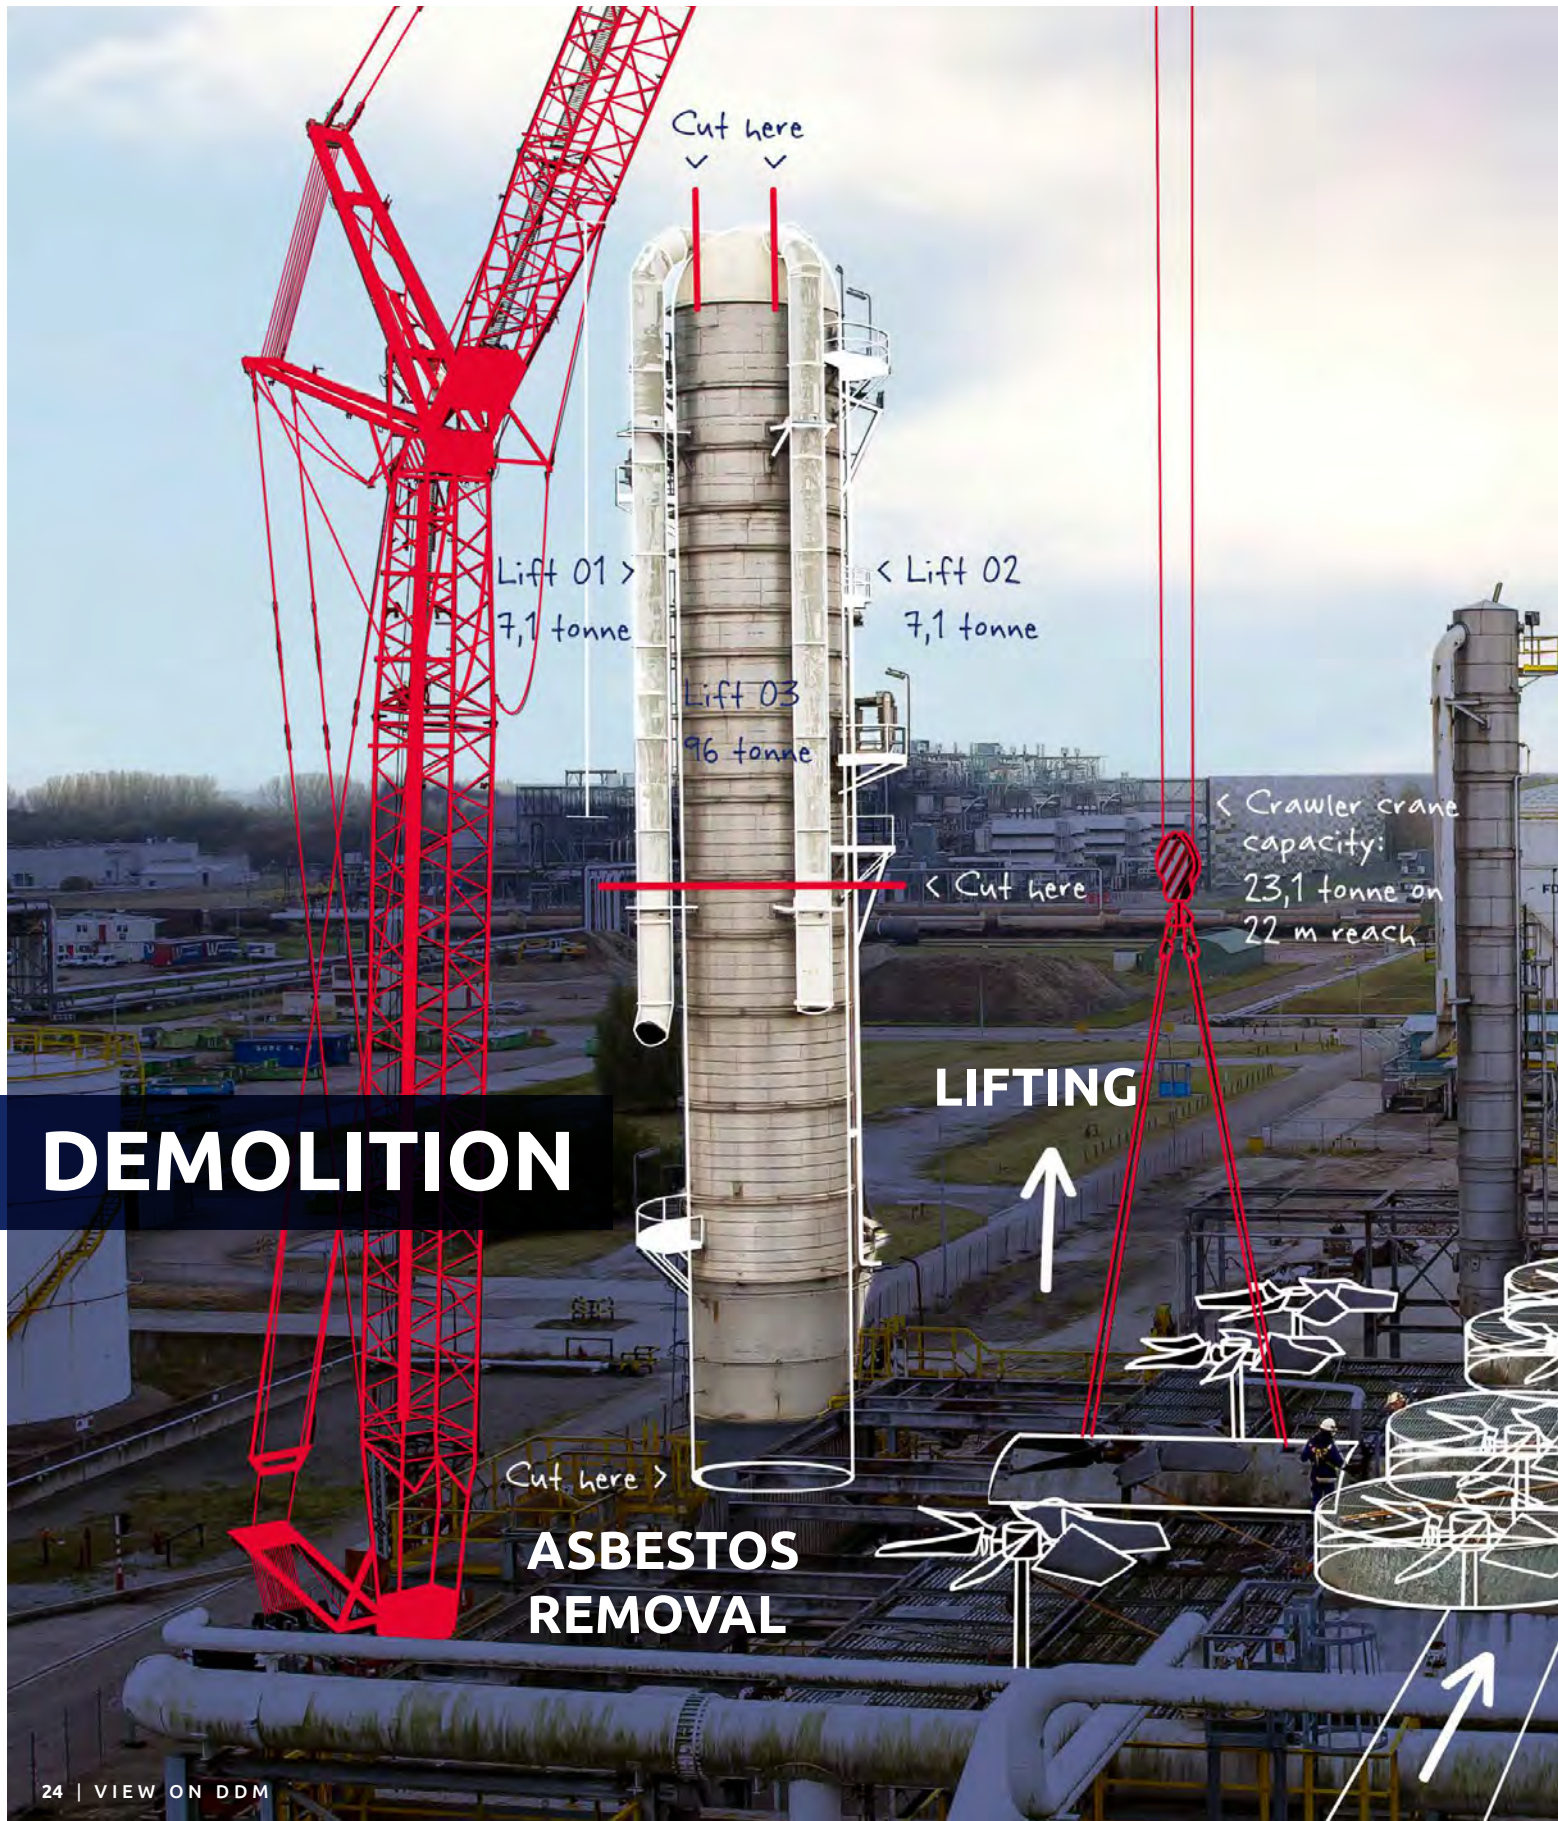
Cut here  
✓ ✓

Lift 01 >  
7,1 tonne

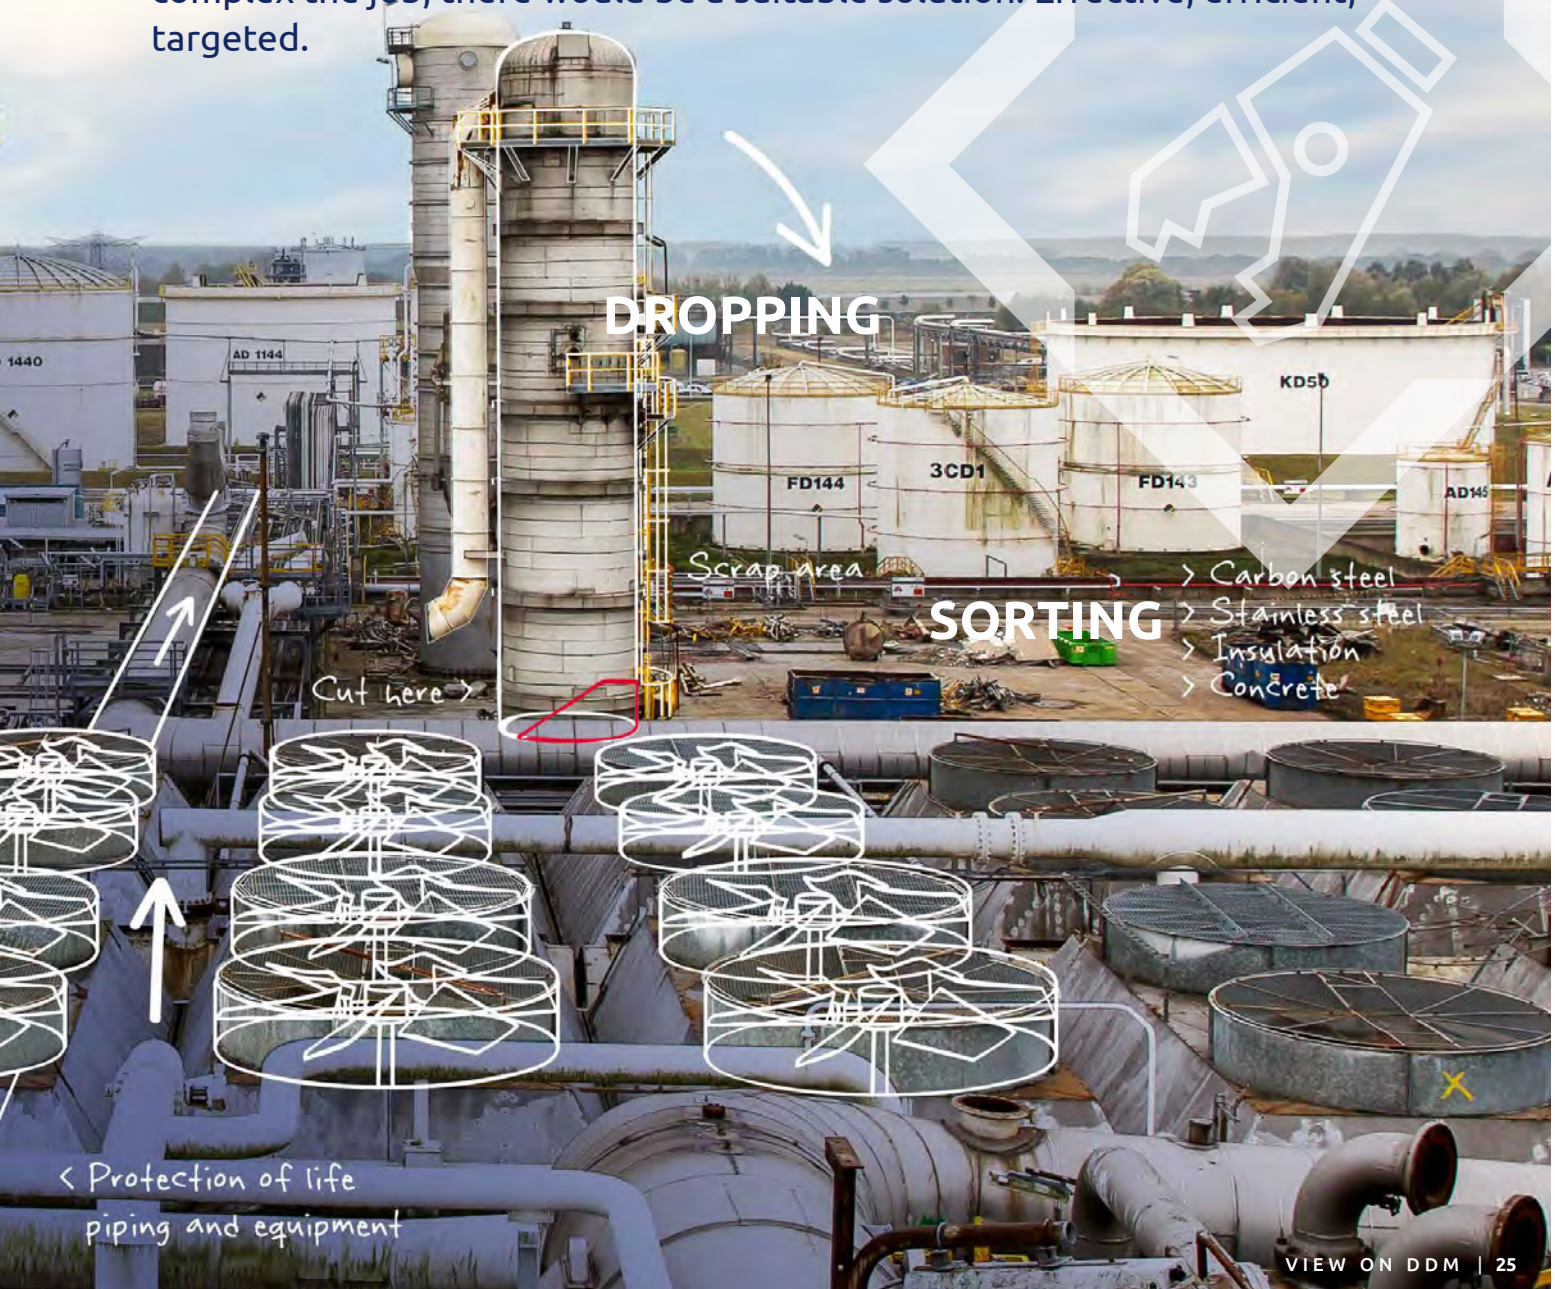
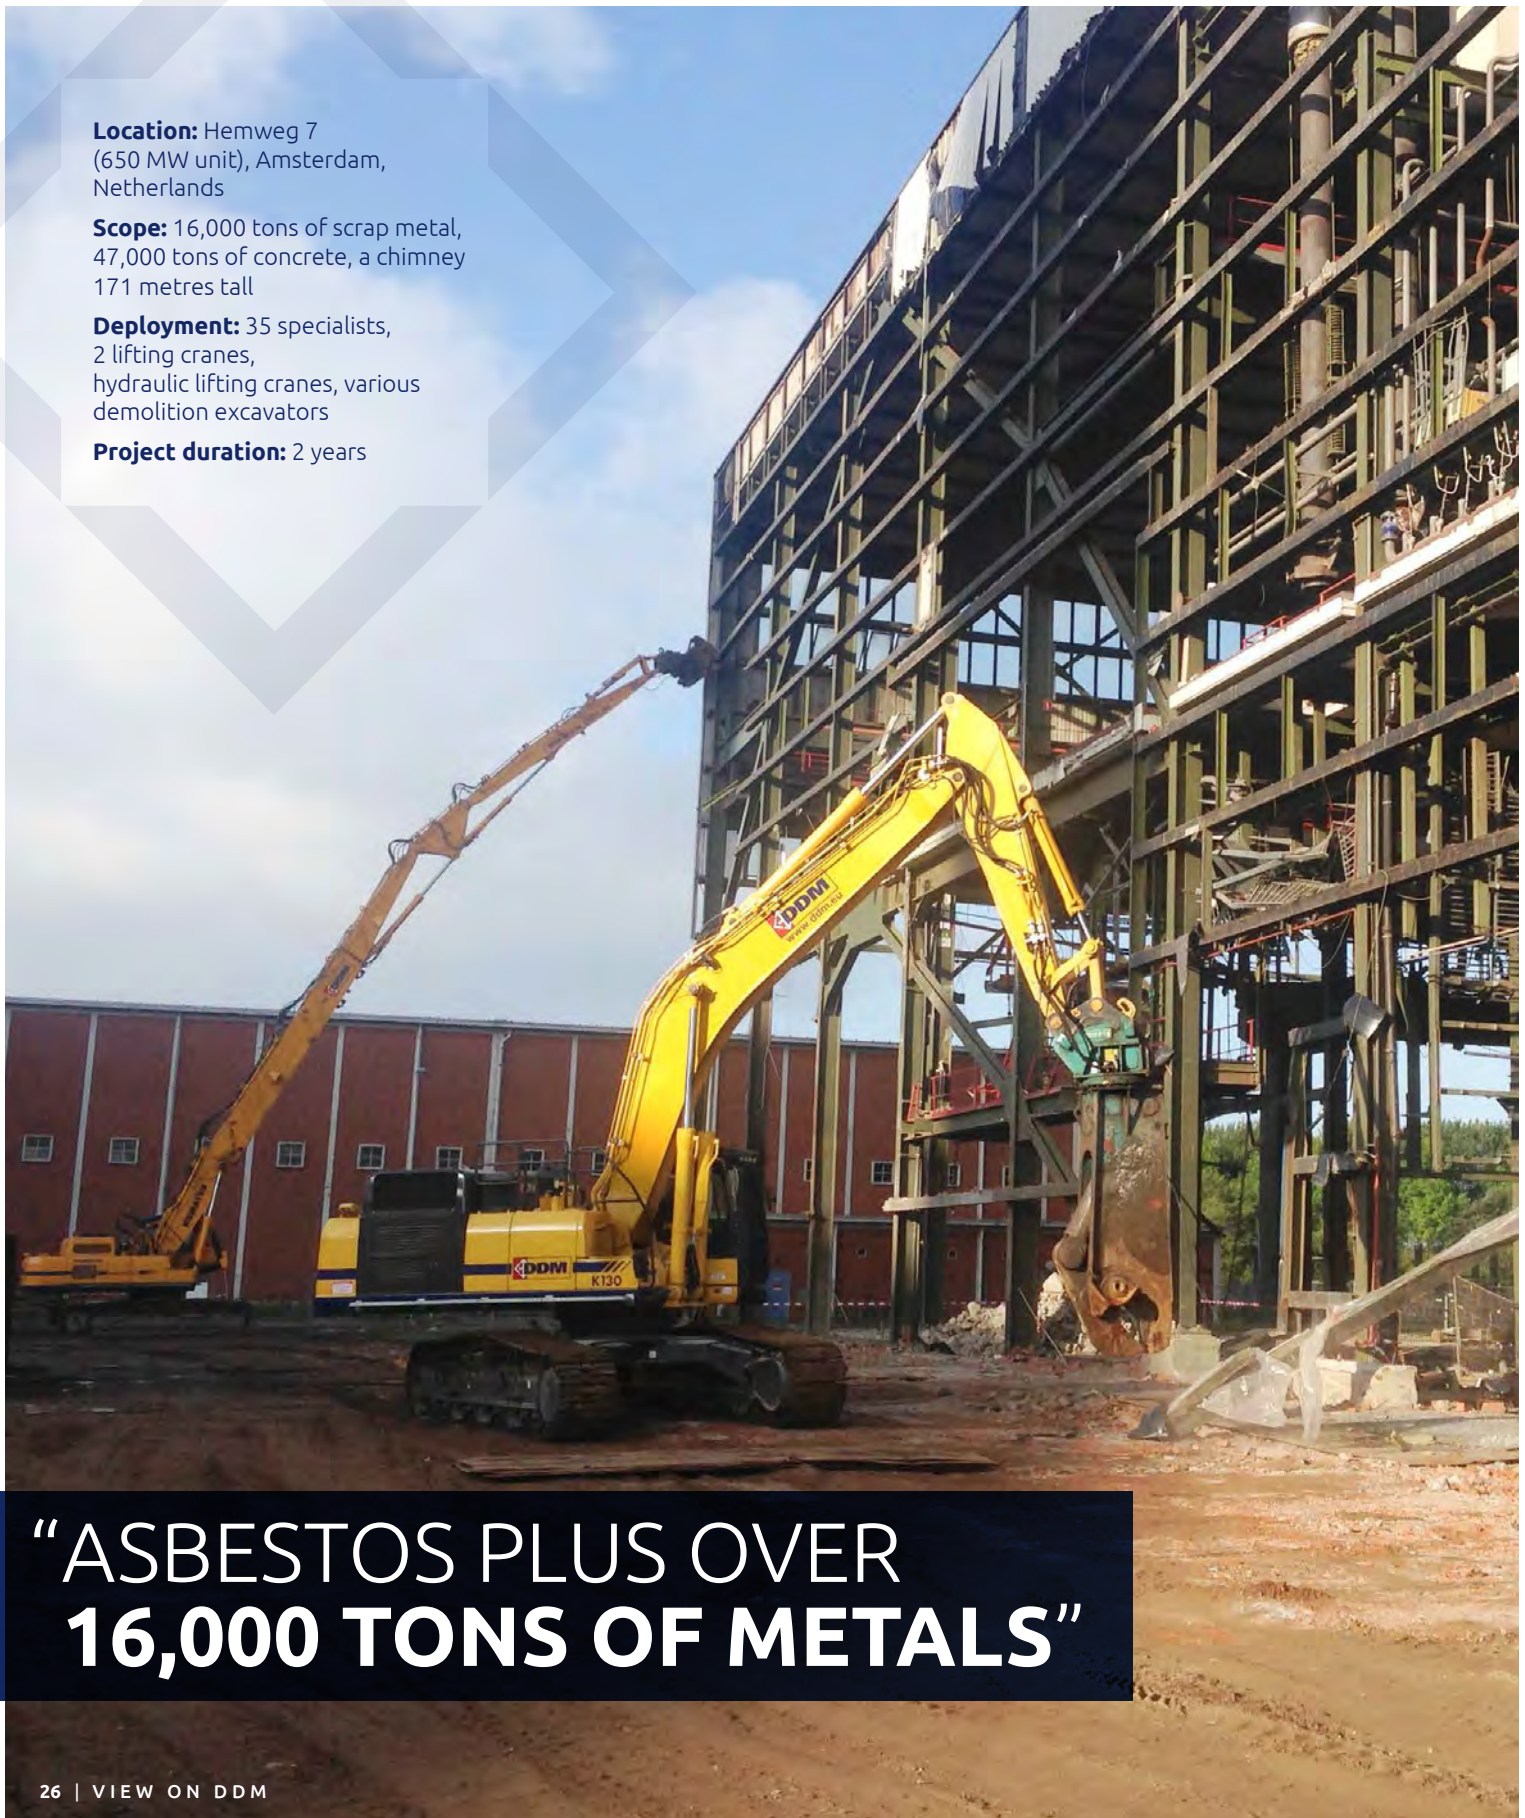
**Scope:** 16,000 tons of scrap metal,  
47,000 tons of concrete, a chimney  
171 metres tall

First of all, hazardous materials such as asbestos were removed. After the buildings and components had been cleaned and released, the actual demolition could commence. That was done not only with heavy machinery; in some cases the dismantling was precision work done by hand. The boiler was stripped completely.

complete internal duct using strand jacks allowed all the harmful materials – including the internal duct – to be expertly removed from the chimney. The concrete tower, 171 metres tall, was then removed by cutting it into chunks from the top down, with the chimney itself acting as its own disposal chute. The 150 MW gas turbine and generator were dismantled. All parts were packaged, preserved and transported for reuse.

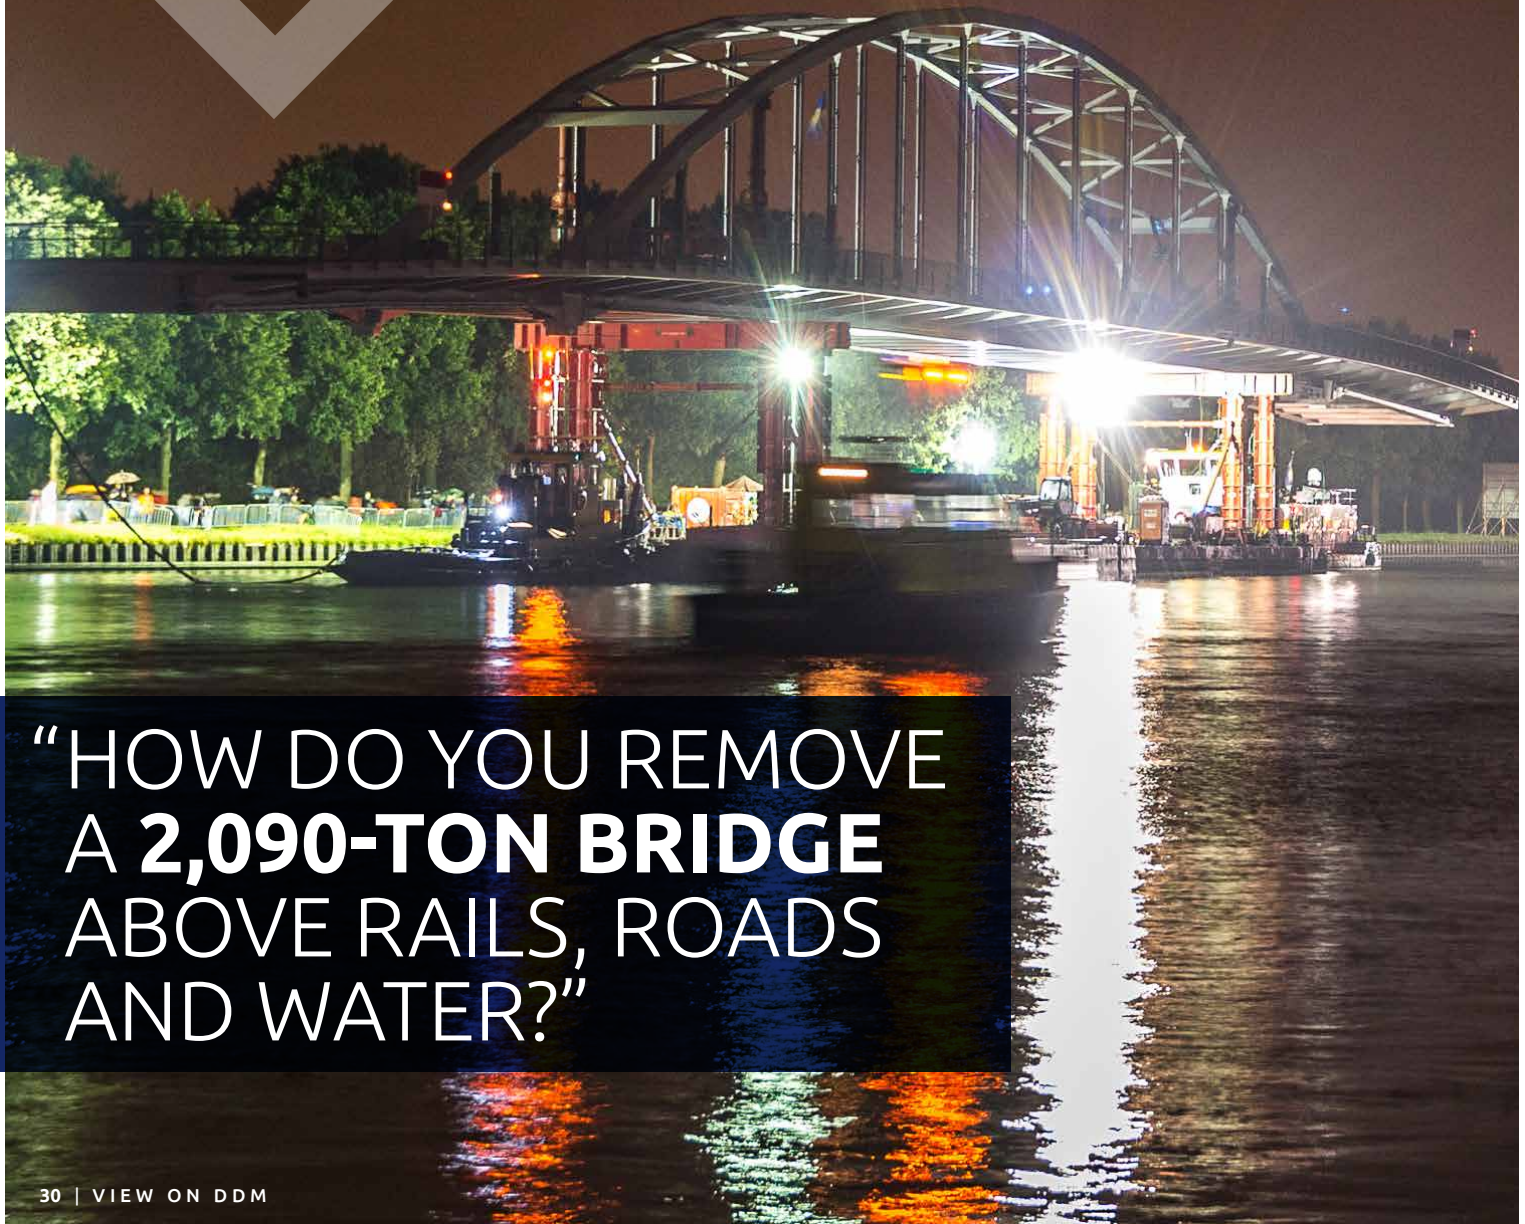
“HOW DO YOU REMOVE  
A **2,090-TON BRIDGE**  
ABOVE RAILS, ROADS  
AND WATER?”

# Removal of 5 bridges across the Amsterdam-Rhine Canal

To avoid nuisance for the surrounding area as much as possible, each bridge had to be removed and replaced in a single weekend. Because of the tight planning, it was decided to use a very challenging method that would require the very maximum in effort and expertise of all parties involved.

As preparation, the asbestos was first removed, under the supervision of and with advice from DDM's specialists. Lifting cranes were placed on both sides of the canal. At the same time, the concrete road deck was removed

After it was shipped away, the bridge was lowered and placed on various supports. DDM had facilities available in Amsterdam for unloading the bridges. To transport the bridge there, the first arch had to be removed. Only then was the bridge low enough to be transported by water, underneath the other bridges crossing the Amsterdam-Rhine Canal.

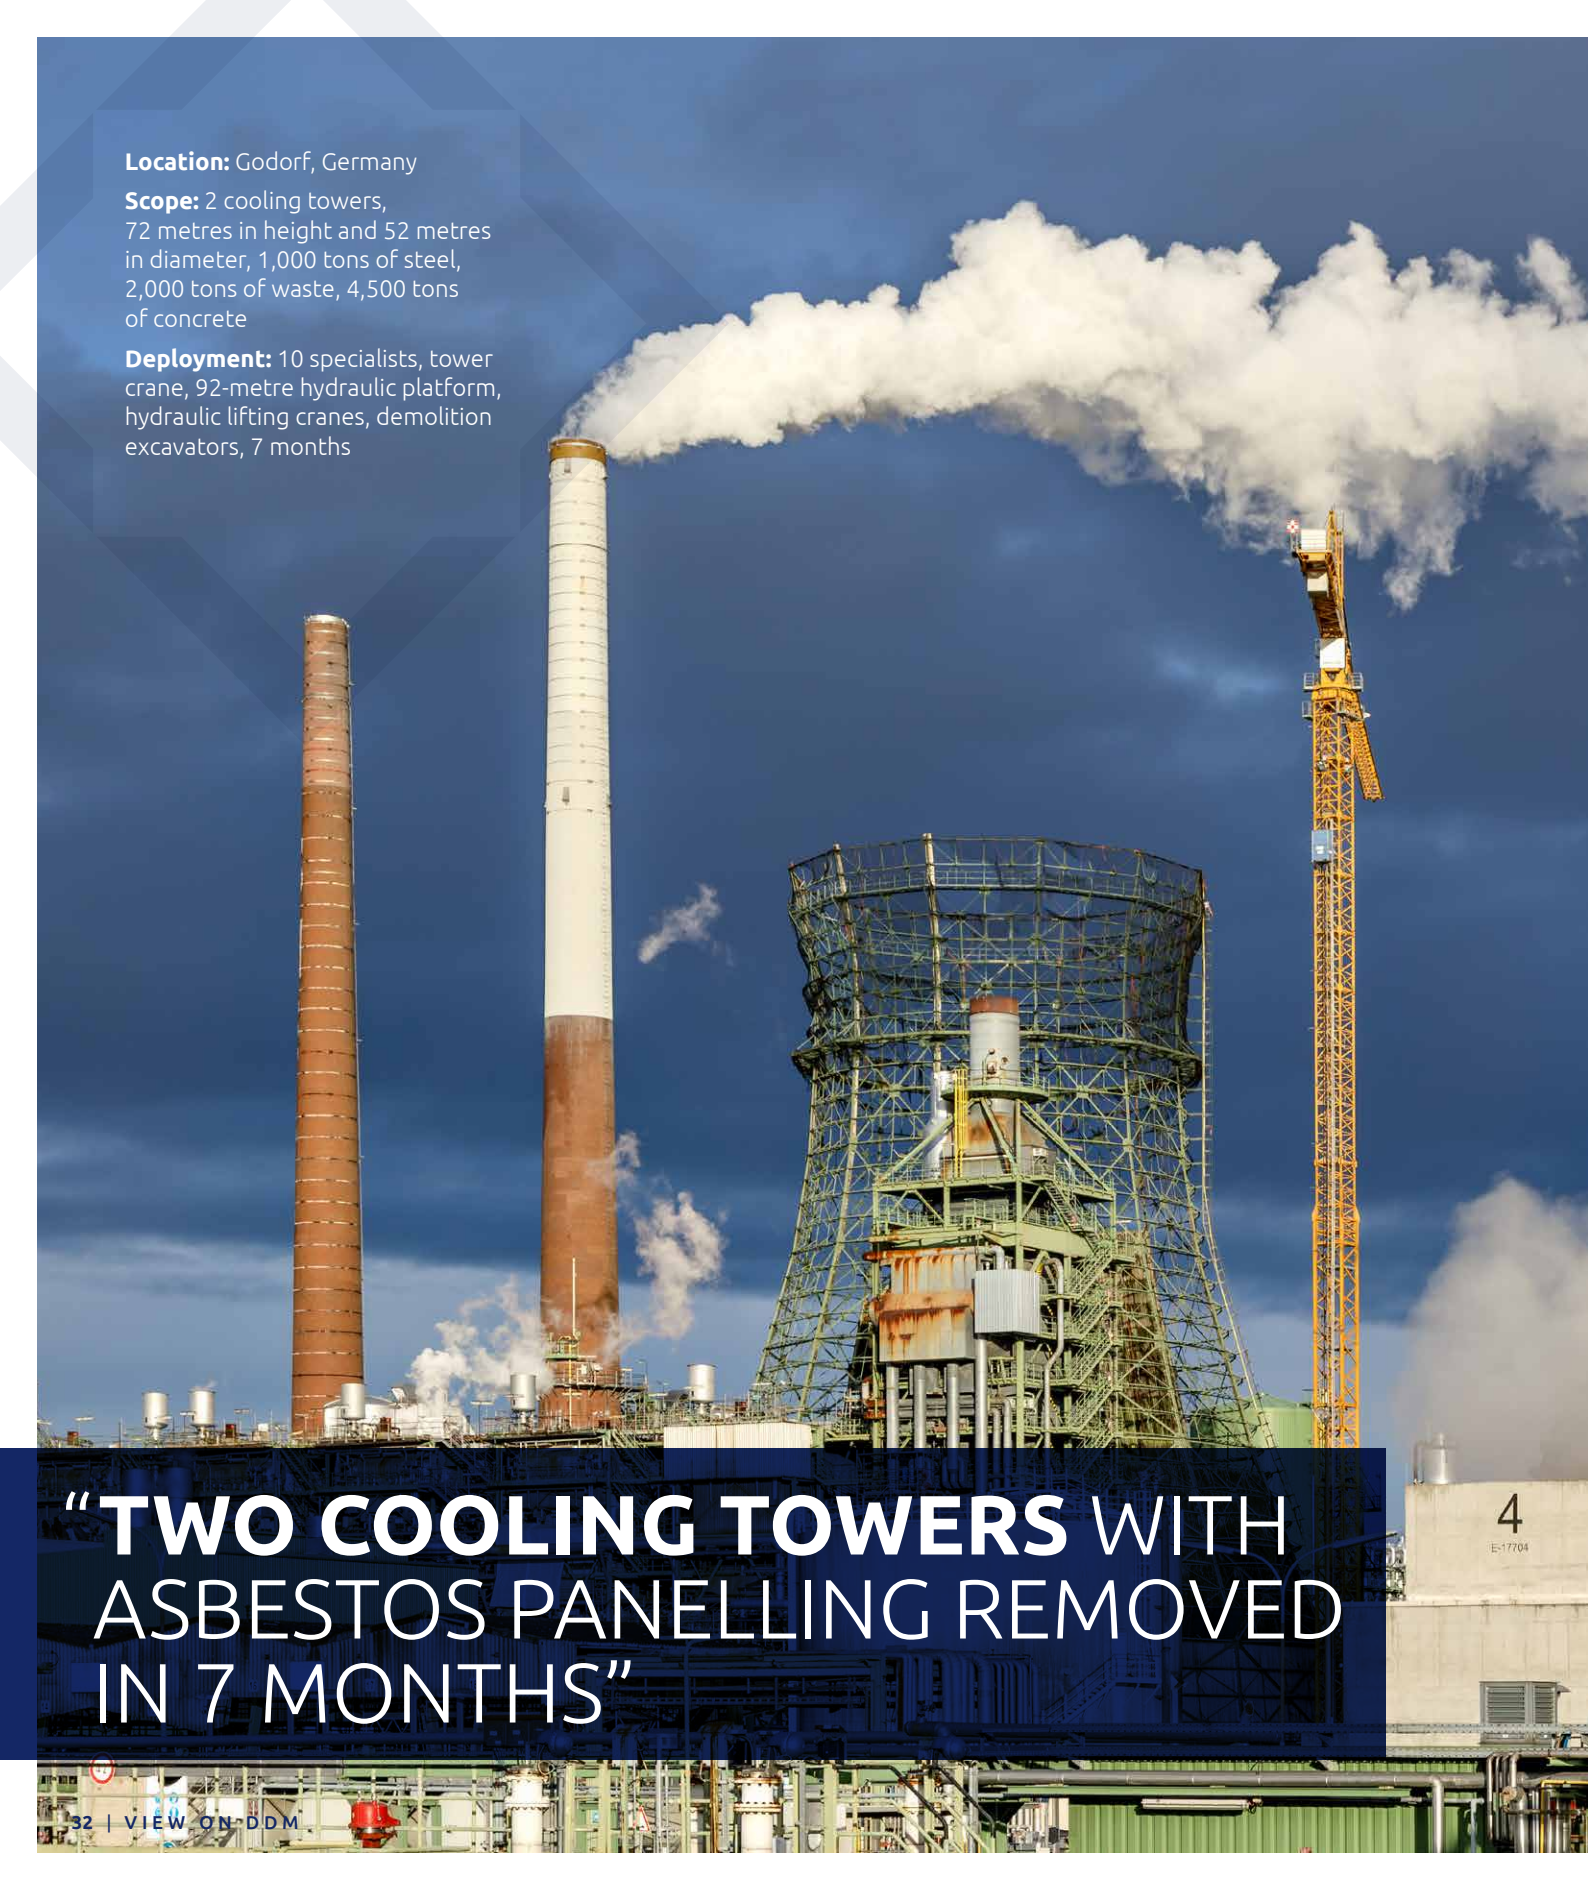
**“TWO COOLING TOWERS WITH  
ASBESTOS PANNELLING REMOVED  
IN 7 MONTHS”**

**Scope:** 2 cooling towers,  
72 metres in height and 52 metres  
in diameter, 1,000 tons of steel,  
2,000 tons of waste, 4,500 tons  
of concrete

The nearest factory system was less than 3 metres away from the cooling towers. To be sure that this factory and others would not be adversely affected by the work, and to be able to work both safely and with the environment in mind, protective scaffolding was placed and nets hung up. Water was also sprayed during all the work in order to limit dust production. Mobile cranes and sorting grabs removed the plastic and wooden interiors of the cooling towers. The plates that contained asbestos were then removed one by one. These had been attached on the inside of the steel structure and had to be detached

at height using a tower crane with a working cage, delete then placed into plastic asbestos disposal bags and taken away. The steel structure was cut into pre-designated pieces and hoisted away with a lifting crane, as per the dismantling sequence and method calculated beforehand by the DDM designers. The concrete foundations were demolished using hydraulic demolition excavators with jack-hammers. After completing the dismantling and demolition work, the site was made suitable for the new construction work that was planned there.

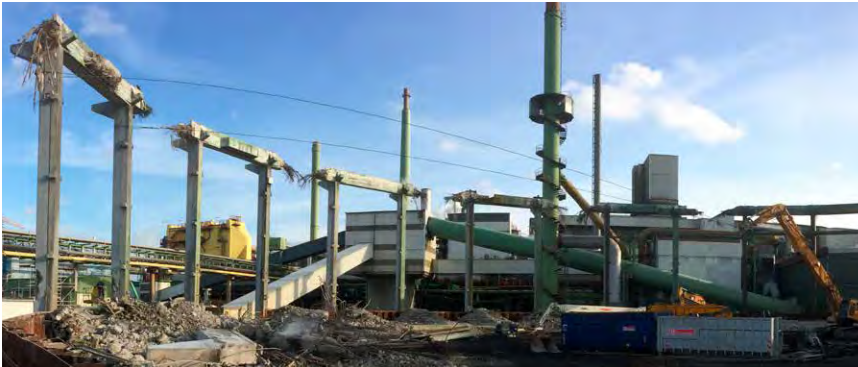
The circular hall had a diameter of 94 metres and it was almost 30 metres tall. Because of the enormous roof span, which was made entirely of concrete, the decision had been made when it was constructed to use pre-stressed concrete. A pre-stressed concrete ring was placed on the outside of the concrete stanchions. A specific construction that demanded a highly specific approach from DDM.

them loose and lift them away. The concrete top ring was removed using two hydraulic lifting cranes.

To eliminate the stresses from the outer ring, it was first weakened at specific spots by breaking the concrete. Once this had been done, the rest of the hall could be demolished by conventional methods. Demolition excavators were used for breaking up the concrete structures and separating out the rebar steel.

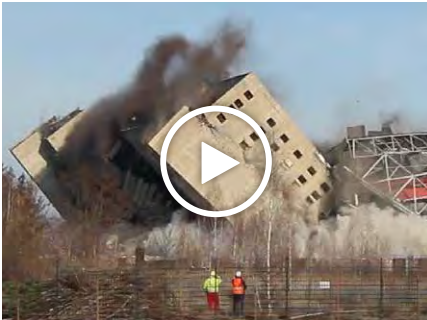
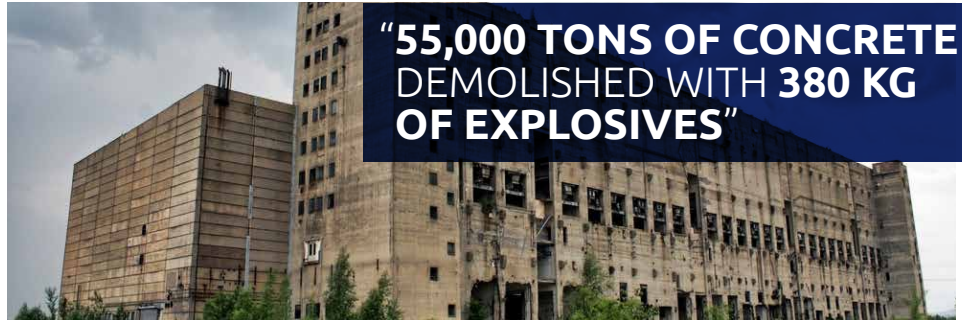
In Görlitz in Germany, DDM set off a controlled explosion that levelled part of a power plant. The resultant rubble was then removed.

Part of the Hagenwerder power plant at Görlitz in Germany had already been removed. Only the bunker building and the machine room were still standing. DDM was given the order for demolishing the buildings. After an extremely short preparation period of 8 weeks, everything was stripped and the explosive demolition was prepared.
